Filter Beds

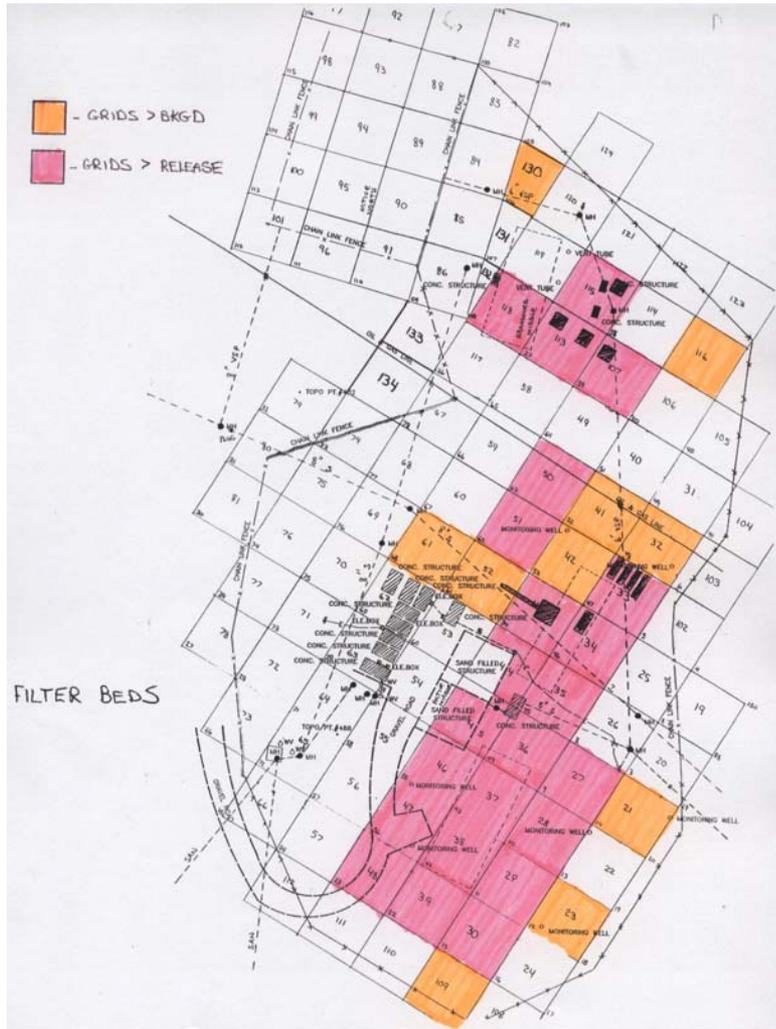
To date, 1806 samples have been taken in the filter bed area. Of these, 11% had activity above background and 2.5% had activity above release limits.

124 grids were sampled, and 16% of these had activity above release criteria.

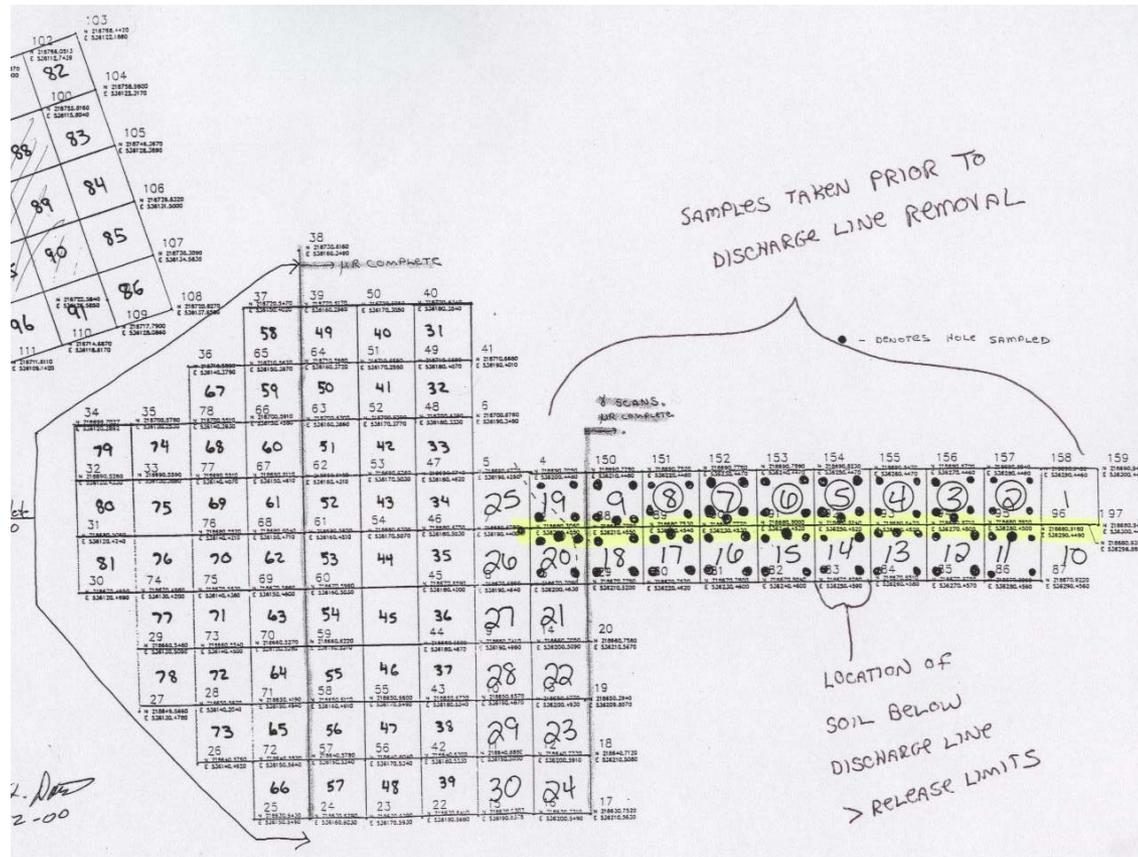
Abandoned Discharge Line – East of Filter Beds

Before the discharge line was removed, 416 samples were taken. During pipe removal, an additional 208 samples were taken. One grid contained soil below the pipe that was above release criteria.

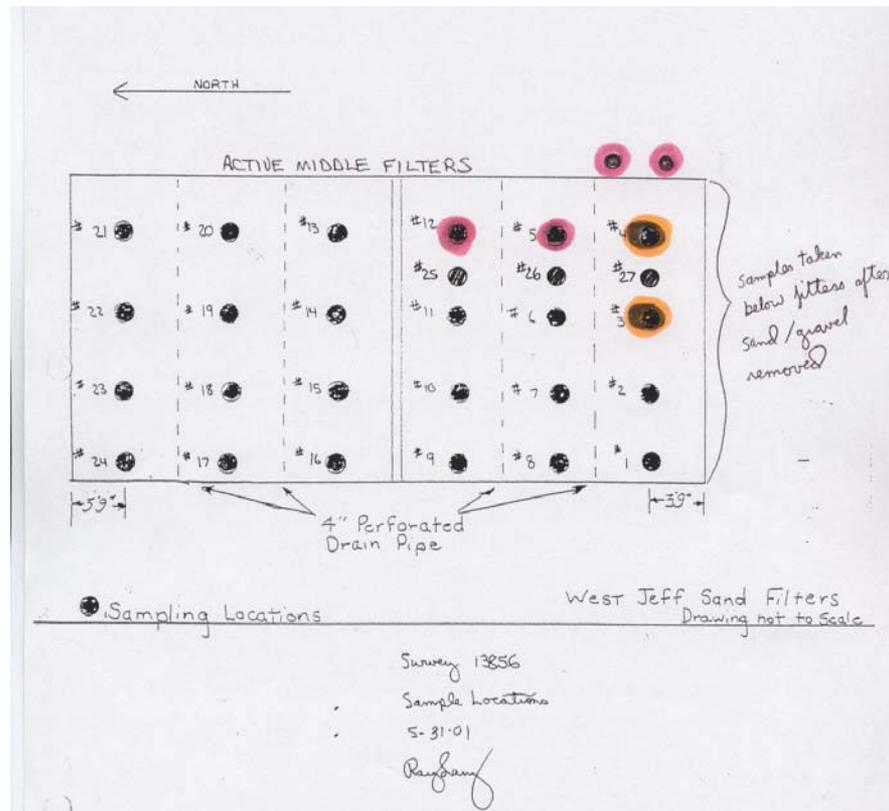
Samples Under Active Middle Filter Bed

The active middle filter beds sit adjacent to the abandoned north bed. After removing the sand media, samples were taken below the beds with several spots having activity above release limits.

Pink areas indicate holes above release criteria.

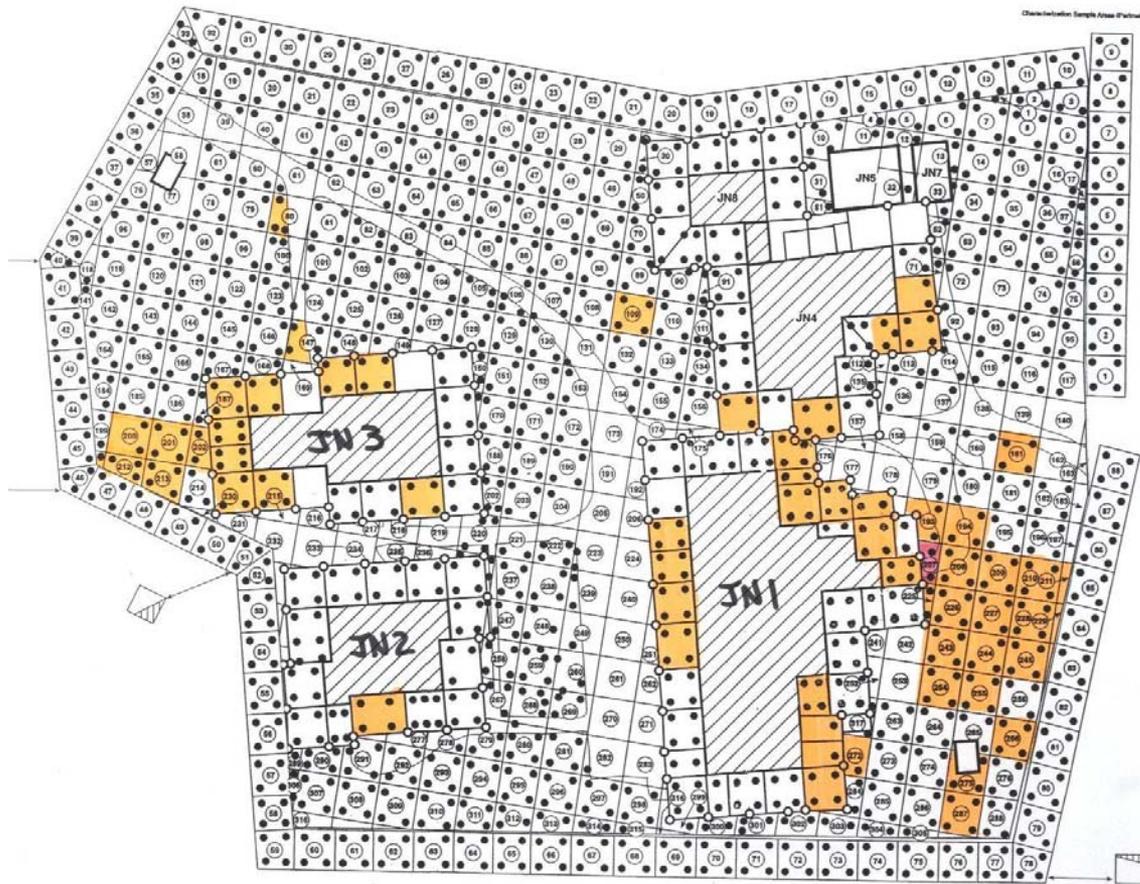
Samples Inside Fence

The area between the perimeter fences has had 688 samples taken. The area within the fence, including the perimeters of the buildings has had 2232 soil samples taken. The orange grids were above background, red above release limits.

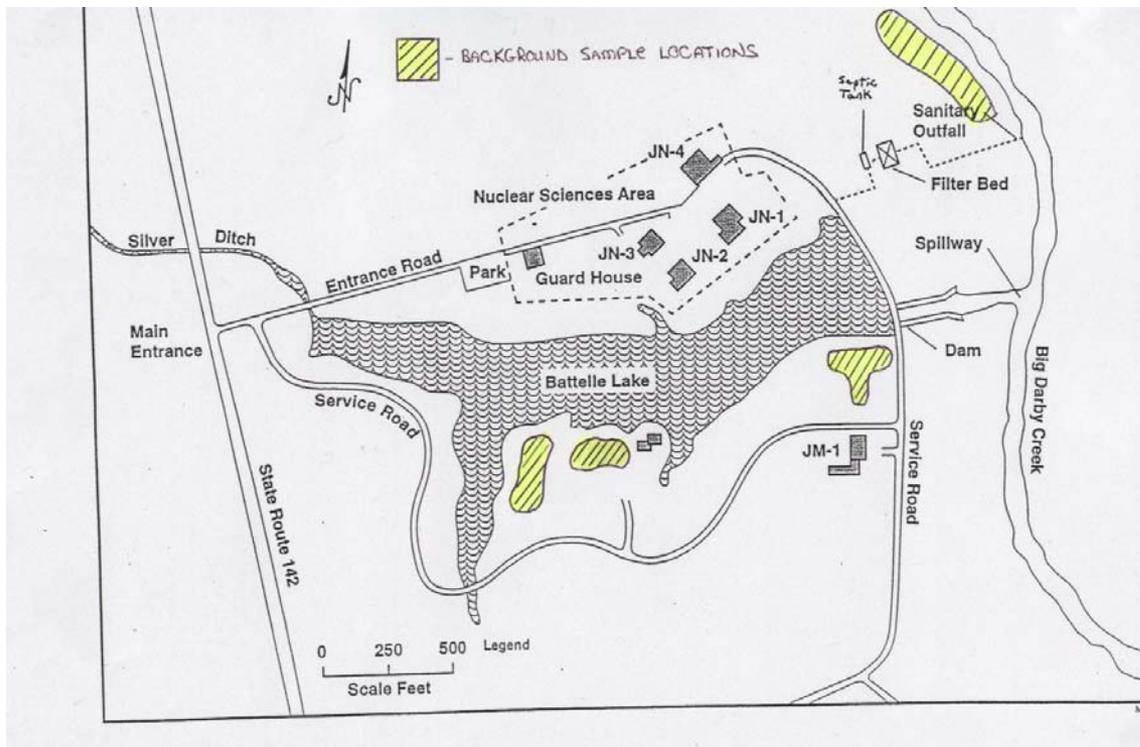
Background Sample Locations

Before any soil samples were taken within a controlled area, 80 samples were taken around the north site for background determination.

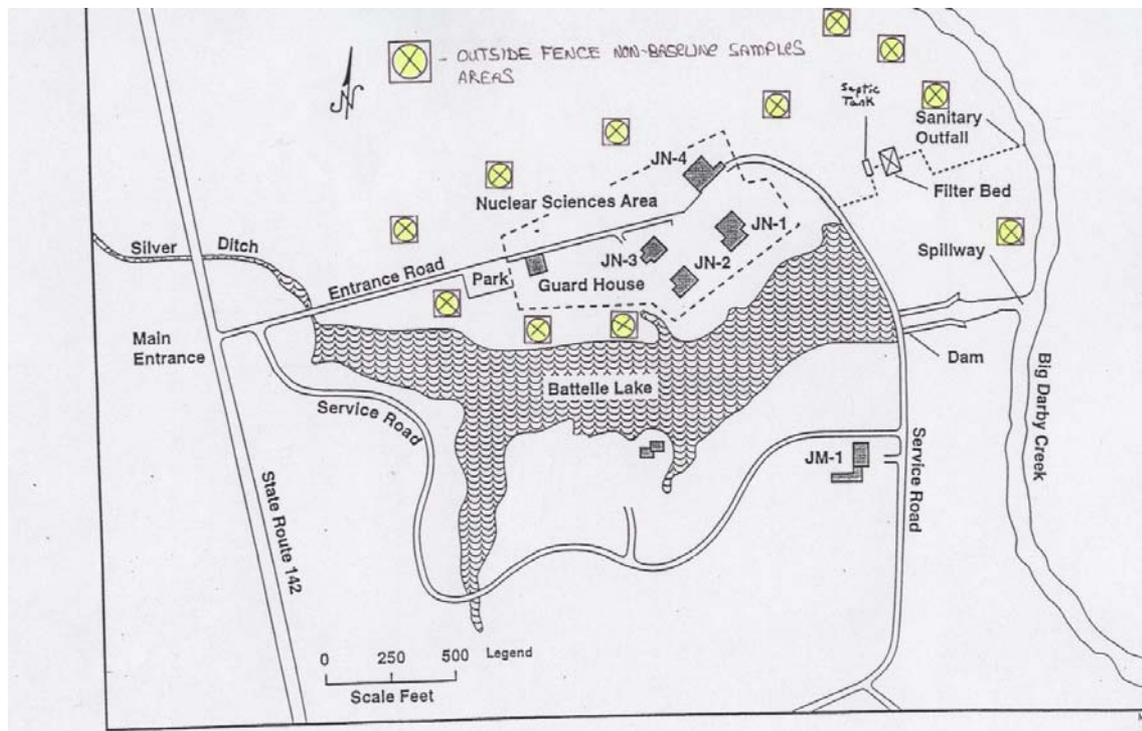
Nonbaseline Sample Locations

Non-baseline soil samples were taken at various locations outside the North Site fence. The total number of non-baseline samples taken was 100.

All samples were below release criteria.

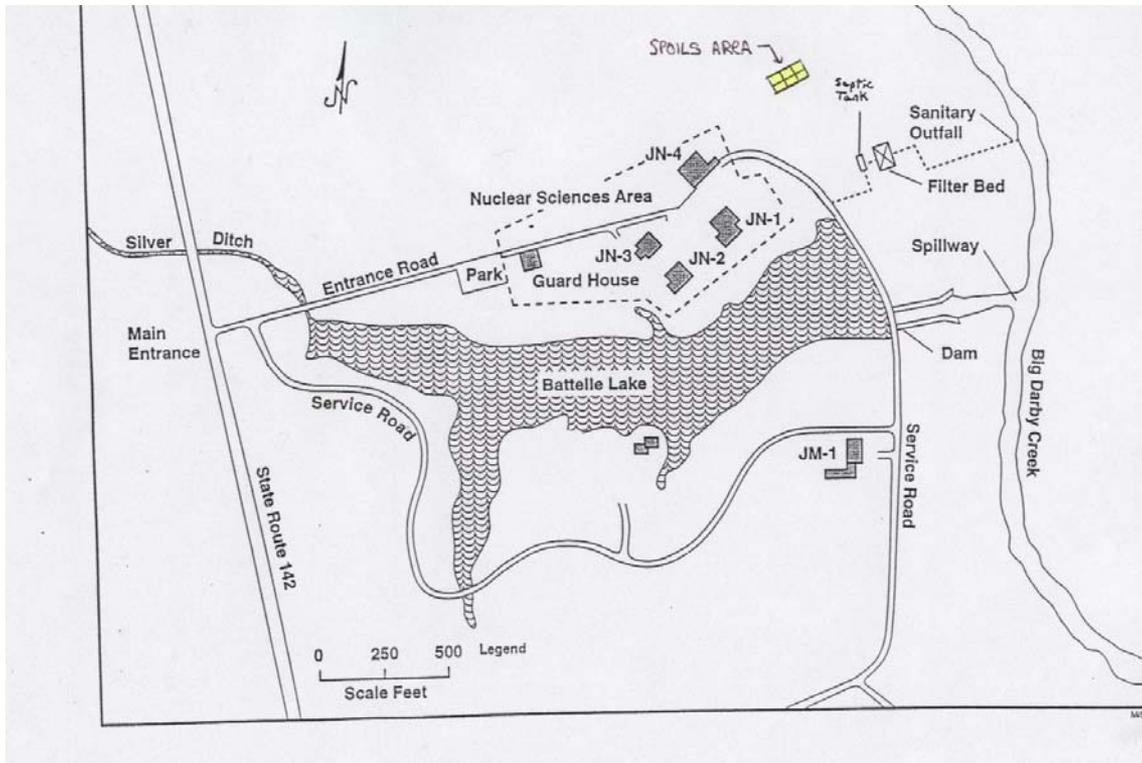
Spoils Location

The JN Spoils area included soil removed from previous excavation projects and needed sampling.

The site is located east of JN-4.

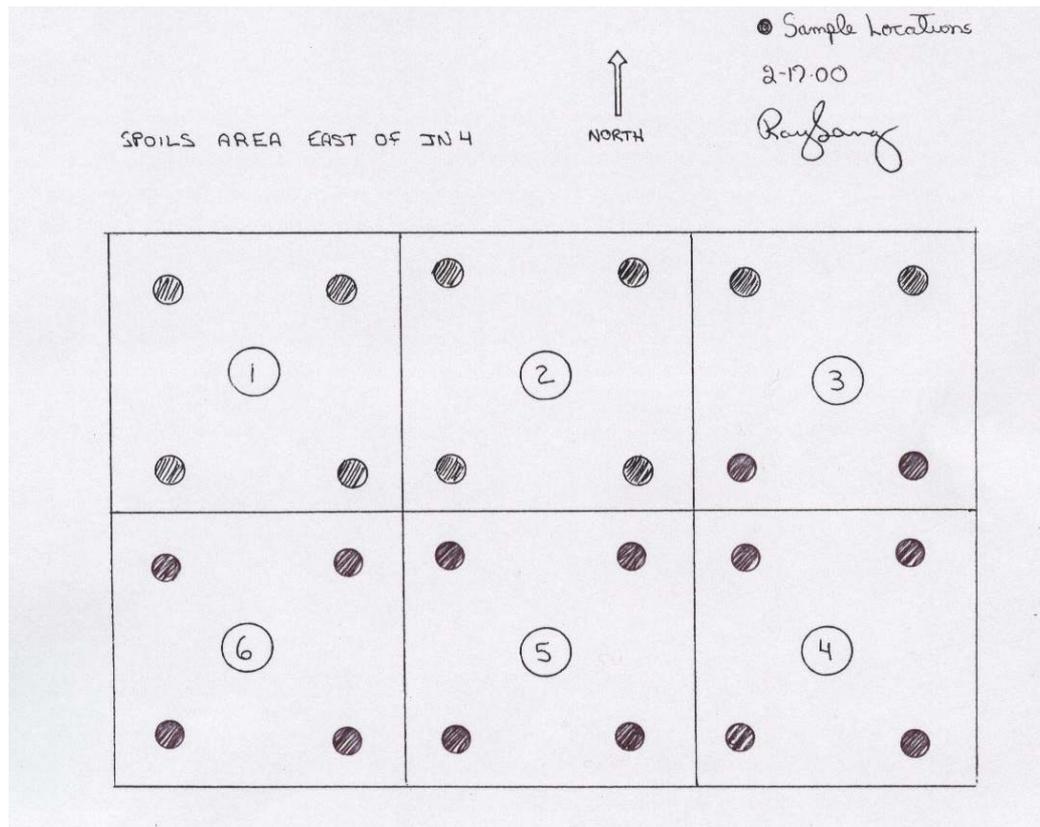
Spoils Grid Diagram

The spoils area included six 100 square meter grids with four sample location per grid. Total number of samples taken: 147.

All samples were below release criteria.
